Nortel WLAN Handset 6100 Series Battery Error: "I2C" Battery Issue (Software RIs 2.x Fix - Build 115.021)

BULLETIN ID: 2009009680, Rev 1
PUBLISHED: 2009-08-25
STATUS: Active
REGION: APAC
CALA
EMEA
GC
NA
PRIORITY: Major
TYPE: Bulletin

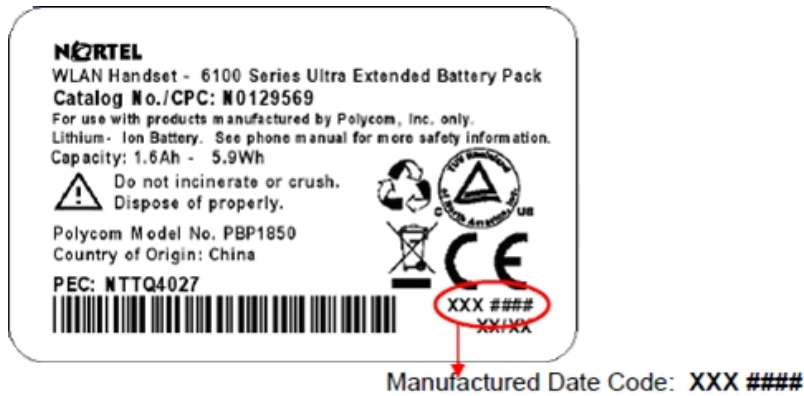
Figure 1: WLAN Handset 6100 Series Battery Pack Product Label Example

To locate the WLAN Handset 6100 Series battery pack "manufactured date code", the user must remove the battery pack from the WLAN Handset and examine the following area on the product label**:

XXX = Three letter abbreviation of the battery pack manufacture "month" (e.g. JAN, FEB, MAR, APR, MAY, JUN, etc)

= Four digit of the battery pack manufacture "year" (e.g. 2008, 2009, etc)

** The "manufactured date code" is in the same location on the product label regardless of the product WLAN Handset 6100 Series "Standard" (NTTQ4025 / N0129567), "Extended" (NTTQ4026 / N0129568), or "Ultra Extended" (NTTQ4027 / N0129569) capacity model.

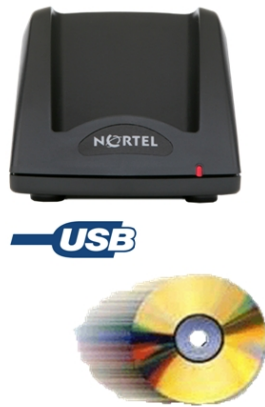
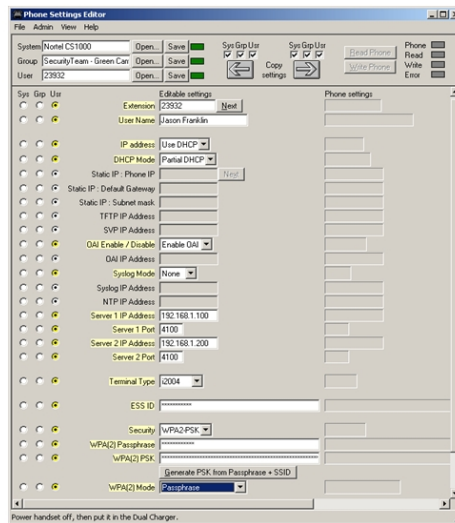
WLAN Handset Administration Tool (HAT) - General Description

The WLAN Handset Administration Tool (HAT) improves the productivity of system administrators by allowing configuration changes or new software builds to be quickly loaded into the WLAN Handset 6100 Series models.

For the WLAN Handset 6120 or WLAN Handset 6140 products, the HAT solution is comprised of a Nortel WLAN handset 6100 Series Dual-slot Desktop Charger (NTTQ4023E6), Desktop Charger local power supply (PEC varies by region), with a separately obtained standard USB cable (USB connector type "Mini-B" to "Type A" to enable it to be connected into a local PC (running Microsoft Windows) running the HAT software (Rls 02.04.00.15 or later). The HAT Software is posted to the Nortel Technical Support Portal for download.

New WLAN Handset 6100 Series installations with the current factory build of 115.019 can eliminate their exposure to the "I2C" battery error issue by upgrading the WLAN Handset 6120/6140 to Software Rls 2.x (Build 115.021 or later) using the Handset Administration Tool software download feature. This update process uses the WLAN Handset 6100 Series Dual-Slot Desktop Charger, WLAN Handset Administration Tool (HAT), USB cable and a Windows PC to allow the software build with the fix to be loaded directly on the WLAN Handset 6120/6140 and would circumvent the "I2C" battery error issue from occurring.
