Business Communications Manager 50 (BCM50) - Manufacturing issue causes BCM50 RIs. 3.0 units to fail

BULLETIN ID: 2009009889, Rev 4
PUBLISHED: 2009-12-23
STATUS: Active
REGION: APAC
CALA
EMEA
GC
NA
PRIORITY: Major
TYPE: Bulletin

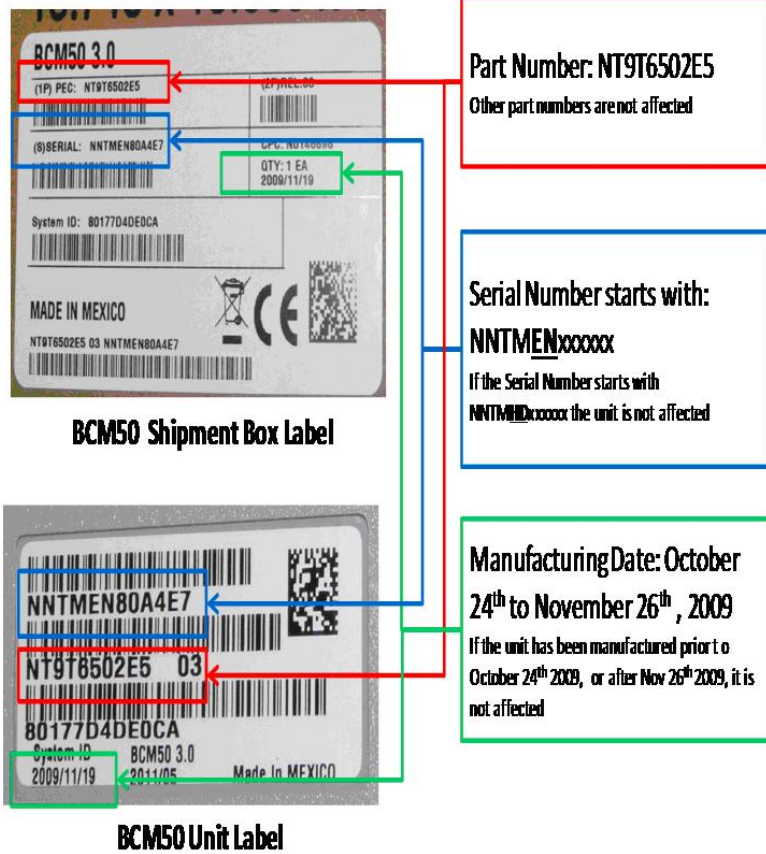
Affected units can be identified through their part number, serial number and manufacturing date.

* The serial number starts with NNTMENxxxxxx

* Manufacturing Date: The unit has a manufacturing date between October 24th and November 26th, 2009

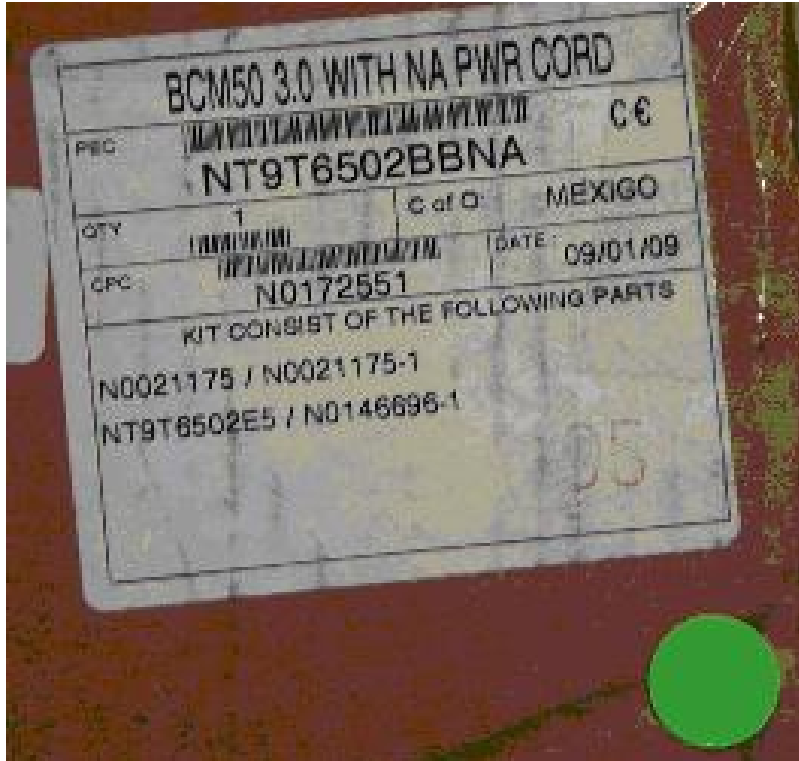
To simplify the identification of good material which is not affected by this issue, Avaya will place a "Green Dot" onto or next to the shipment box label and the unit label of all unaffected units leaving Avaya. This "Green Dot" will be attached to

all good units until the end of 2009.
