Ethernet Routing Switch (ERS) 8600 8692SF Modules may experience an issue at initial power up.

BULLETIN ID: 2007007885, Rev 3
PUBLISHED: 2008-03-28
STATUS: Retired
REGION: APAC
CALA
EMEA
GC
NA
PRIORITY: Major
TYPE: Bulletin

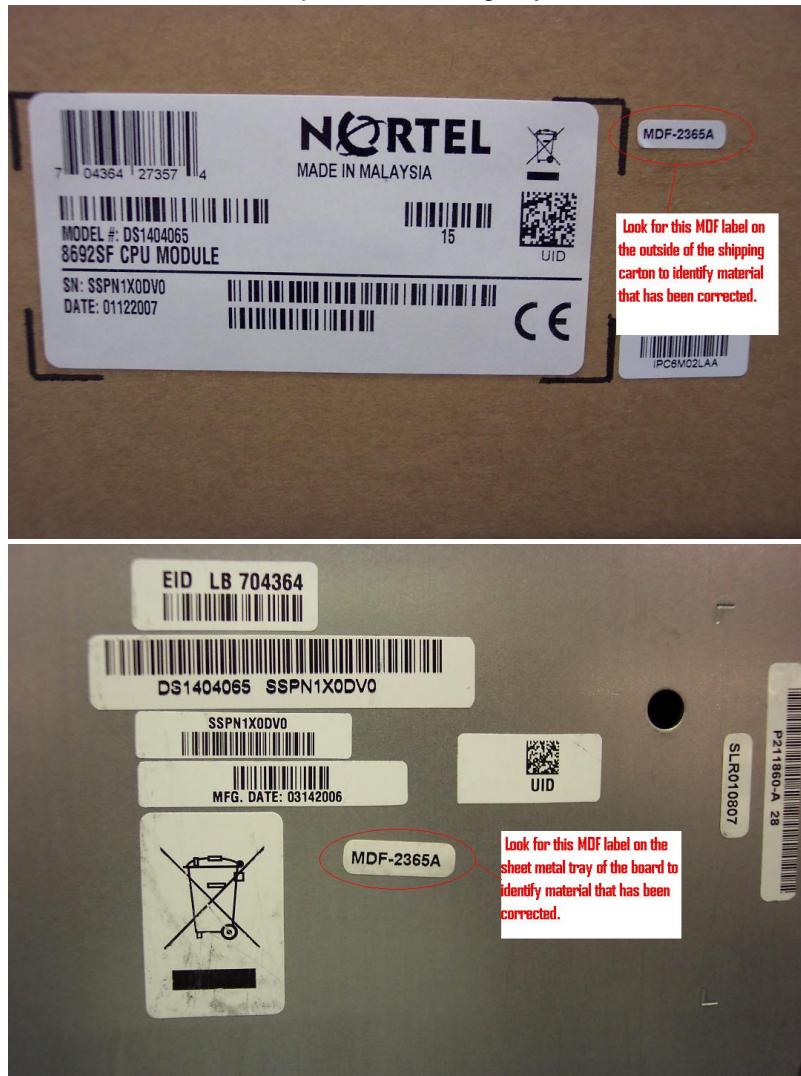
PLEASE NOTE: That any card with an MDF-2365 or MDF-2366 label should not be returned, all cards with this label have been reworked to incorporate the fix, and WILL NOT see this issue, even though the command above will not show the Revision update. The labels can be found on the sheet metal tray of the PCB, and on the outer shipping carton (see photos).

Please check for the MDF-2365 or MDF-2366 label prior to returning any modules to Nortel.

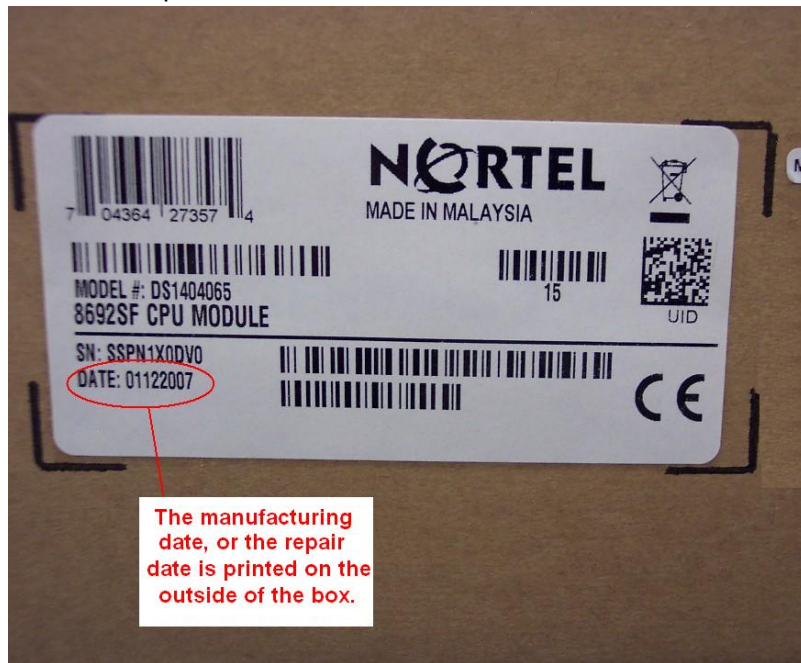
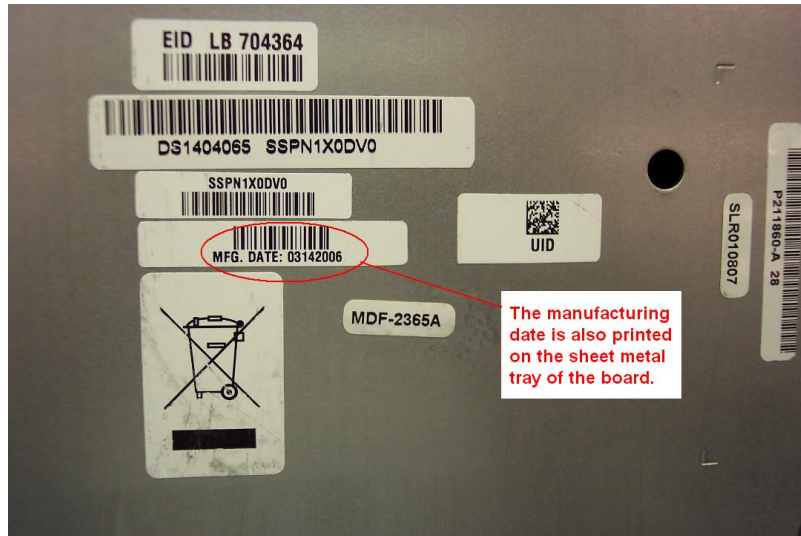
The manufacturing date or the date of repair of the unit can found by checking the label on the outside of the box. If the unit has been removed from the box or is already installed, the manufacturing date can be obtained by checking the sheet metal tray of the board. Please see the pictures below for more details.

- If the date of manufacture or the repair date of the unit is after 01-January 2007 [irrespective of an MDF label], the unit will have had the fix applied and does not need to be returned.
- If the unit, or the packaging has either of the following MDF labels (MDF-2365 or MDF-2366) [irrespective of the date of manufacture or date of repair], the fix will have been applied and the unit does not need to be returned.
- If the date of manufacture or date of repair of the unit is before 01-January 2007 and the unit does not have either of the following MDF labels (MDF-2365 or MDF-2366), the unit will be affected and should be returned.
