Nortel Ethernet Routing Switch 8600

Release Notes — Software

Release 7.0

NN46205-402

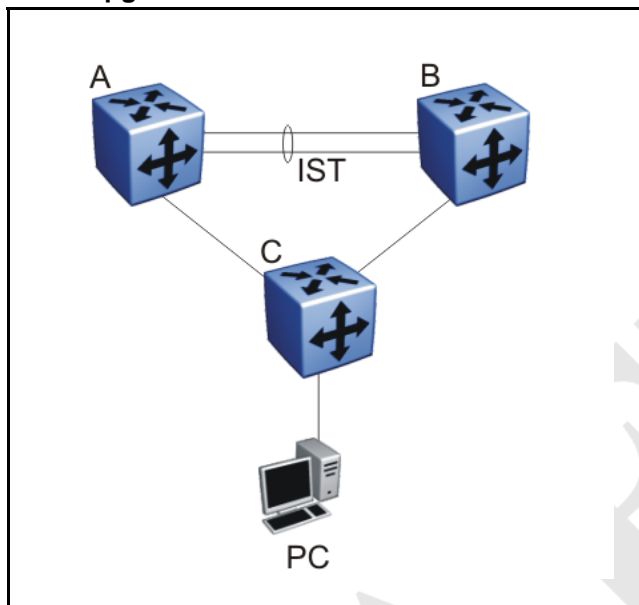
Figure 1
SMLT upgrade scenario

Consider the following figure, showing a triangle SMLT setup. In this case, the user intends to upgrade the IST peers (that are currently running 5.1.0.0) to 7.0.0.0.

Assume the user Telnets from the PC to manage switch A and switch B. When the Telnet traffic generated by the PC arrives at switch C, depending on the MLT hashing algorithm, the traffic can be hashed to the link toward switch A or switch B. So, it is possible to have a situation where the Telnet management traffic destined for switch A flows through switch B and vice-versa.

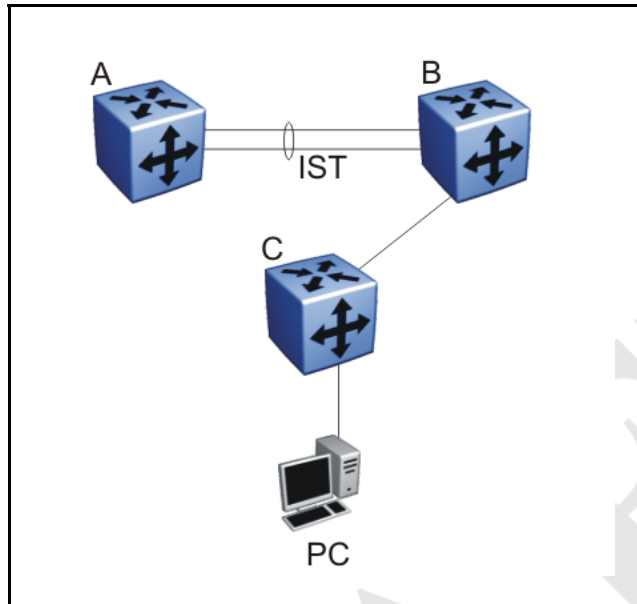
Figure 2
SMLT upgrade scenario after upgrading switch A to 7.0.0.0

Assume that the user upgrades switch A to 7.0.0.0. Due to the SMLT behavior, the network diagram now looks like the following figure.

In this situation the PC cannot communicate with switch A, and as a result Telnet access to switch A is unavailable. For in-band management, you can alternatively Telnet first into switch B, and then Telnet to switch A from there.
