Nortel Ethernet Routing Switch 8800

Release Notes — Software

Release 7.0

Release: 7.0
Document Revision: 04.01

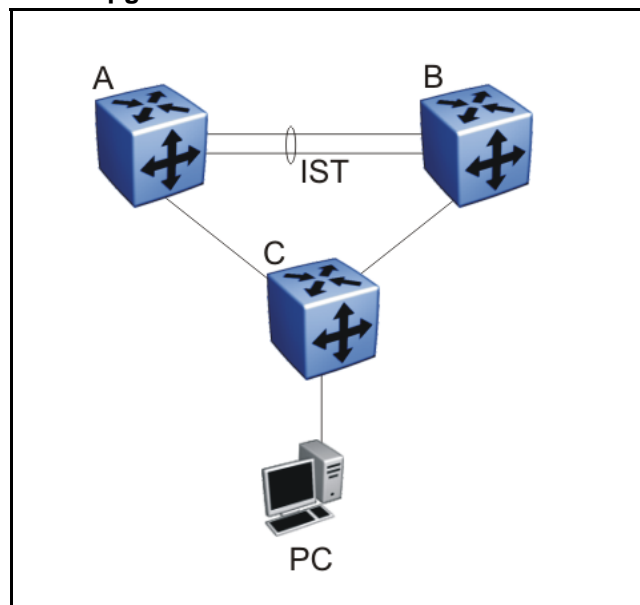
Figure 1
SMLT upgrade scenario

Consider the following figure, showing a triangle SMLT setup. In this case, the user intends to upgrade the IST peers (that are currently running 5.1.0.0) to 7.0.0.0.

Assume the user Telnets from the PC to manage switch A and switch B. When the Telnet traffic generated by the PC arrives at switch C, depending on the MLT hashing algorithm, the traffic can be hashed to the link toward switch A or switch B. So, it is possible to have a situation where the Telnet management traffic destined for switch A flows through switch B and vice-versa.
